TOO much H₂O? Not a problem!

Paxton's innovative products eliminate excessive moisture and labeling machine downtime

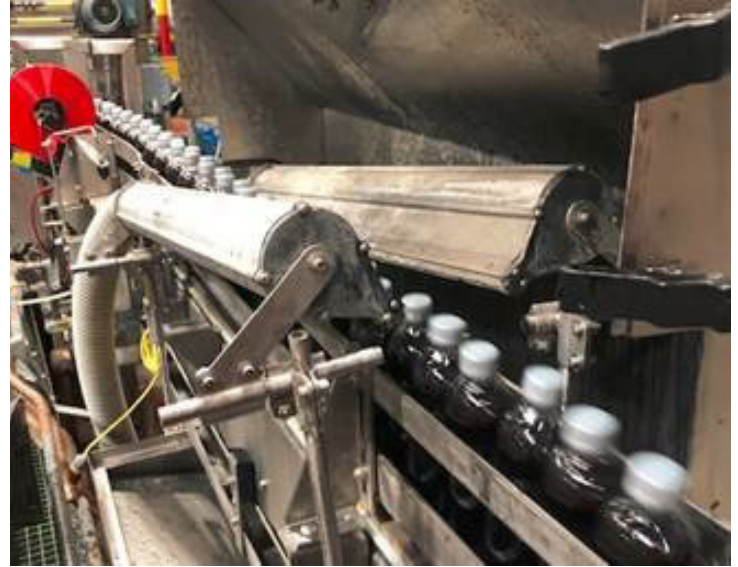
Old Air Knife System

Until now, the bottling company has been using a 20-year old blower system for drying. Their previous system fails frequently due to bearing and belt issues. Additionally, they paired too many air knives to their previous blower causing inefficiencies in their drying process, specifically, moisture trapped under neck and on the side walls of the bottle. These issues created the following collateral damage:

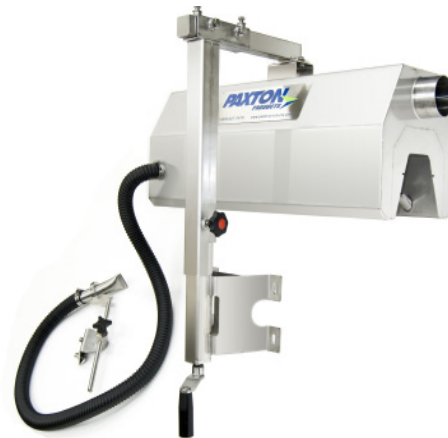
With all the information provided, the Paxton team determined that the bottling company's labeling line problem could be solved using a combination of Paxton's air products. Paxton's Application Engineers proposed the use of a 24 nozzle CapDryer System in order to remove all of the water from the cap of the bottle. The CapDryer consists of a stainless-steel manifold, whose integrated 24 nozzles target the cap and

neck of the bottle from all directions. It utilizes 750 cfm of air at 60 inches of water column pressure, and is widely used in conjunction with vision systems, to reduce false rejects.

By replacing an outdated drying solution with Paxton's CapDryer system, the bottle neck and lid are completely dried, preventing any water from landing on the labeler. Mold growth on the labeler is eliminated; and further corrosion of the bottle carousel is prevented. Additionally, by switching to a Paxton drying system, the bottling company saves at least 7 hours every 4 weeks of downtime from excessive water being sprayed onto the equipment.
