Eliminating a Powdery Mess during Packaging

The Paxton Ionized Air System removes sports nutrition powder adhering to bottles to improve production efficiency and labeling quality.

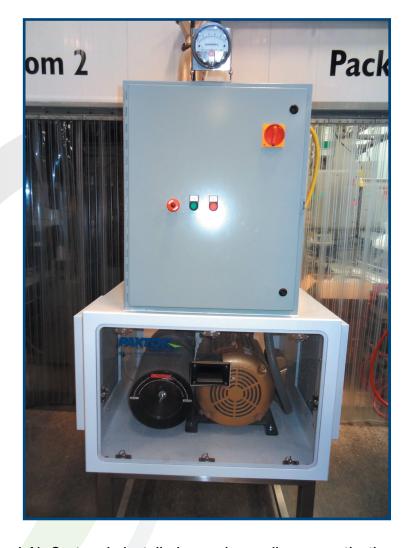
Nutrablend now uses a Paxton 20 hp AT-1200 blower with polypropylene washdown enclosure for noise dampening. The Paxton blower is equipped with 3 ionizing air knives – one 12" knife for the top,

two 18" knives for the sides. While the Paxton Ionized Air System is installed on only one line currently, the blower was sized to run 2 lines, so currently the unit is throttled using a variable frequency drive.

Paxton Ionized Air System was installed at Nutrablend's Brantford plant, along with a custom-designed dust enclosure. The dust enclosure contains the powdery dust using a vacuum system. The enclosure runs at a negative pressure to ensure that all the powder is collected.

Paxton Ionized Air System blows Ionized Air to eliminate the static holding the powder to the bottles. The powder is then blown into the dust collection vacuum system.

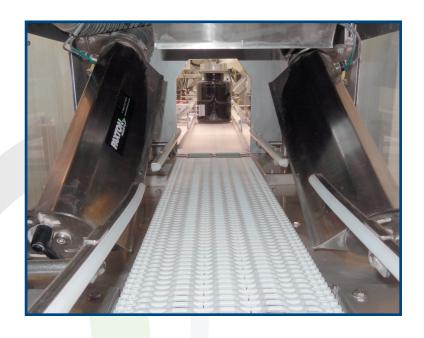
Installation of the new system also resulted in another, unanticipated bonus in product quality. The powder granules which previously stuck to bottles after wiping caused the labels to have bumps. The new technology eliminated this minor defect in product appearance.
